## Site Inspection Report Summary

**Property Address:** 6231 PA-88 Finleyville, PA 15332

**Inspection Date:** 06/10/2020

## **Photo Report of Koteles Garage**

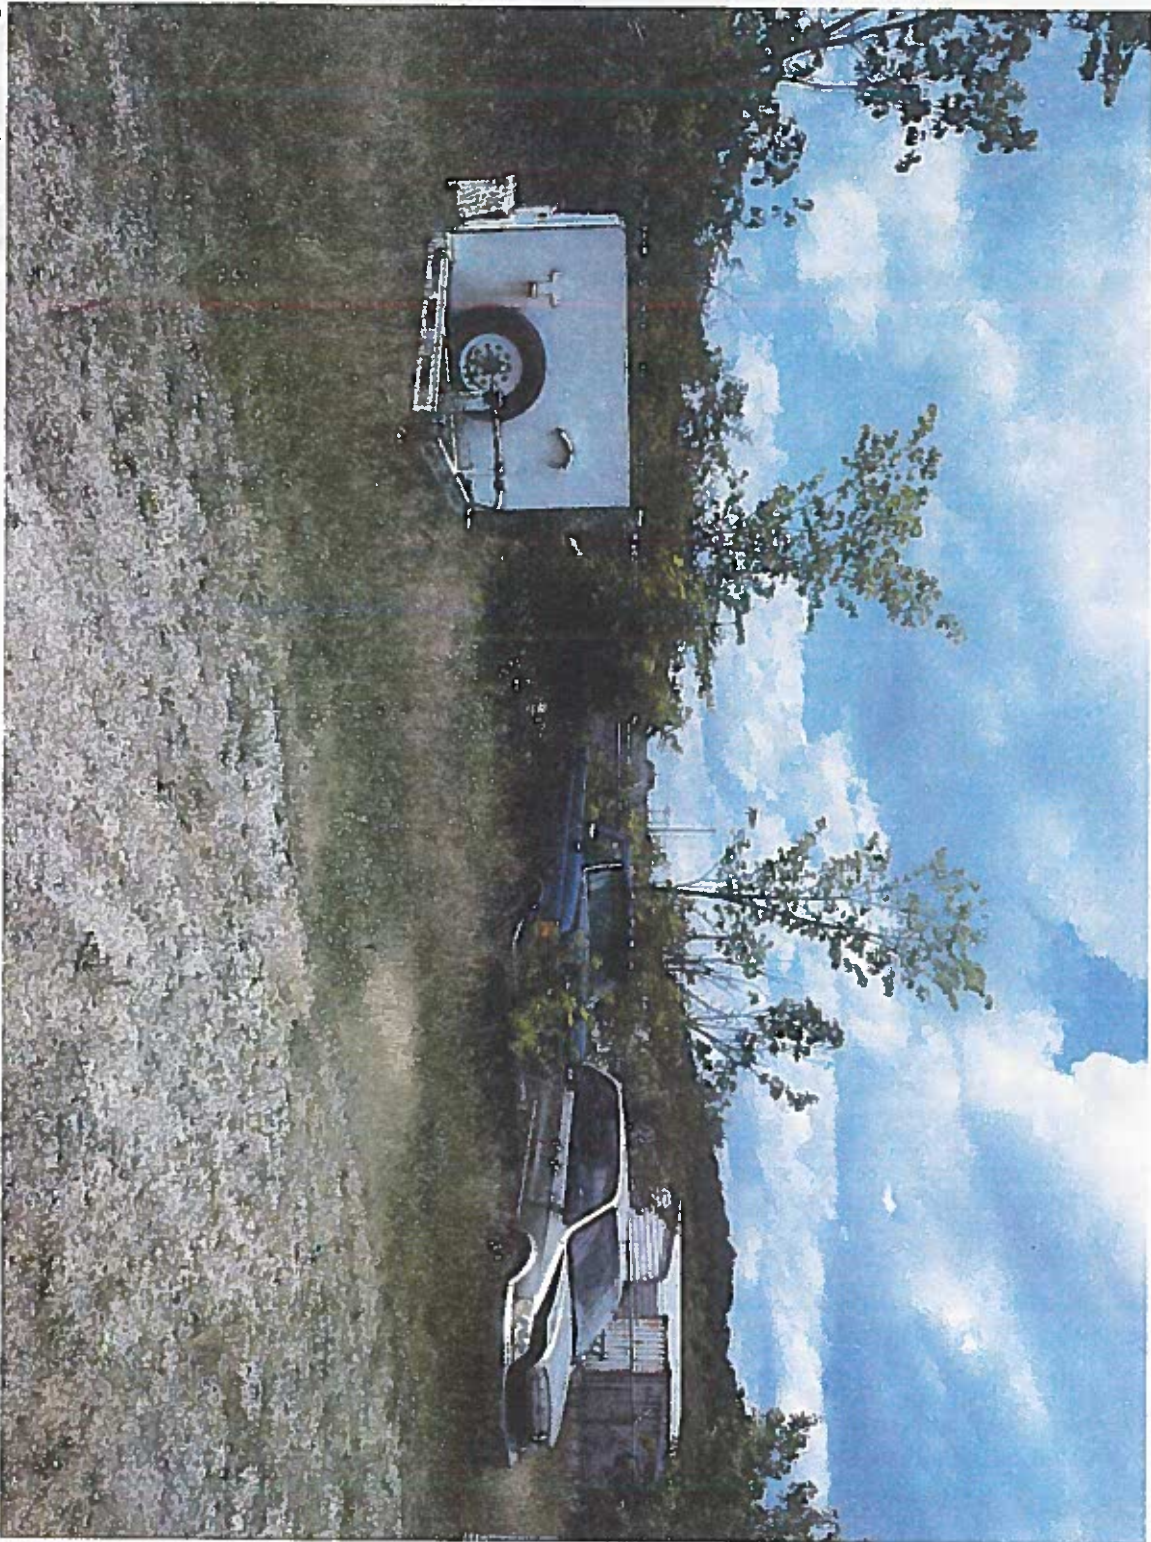
Overgrowth and weeds on the rear lot.

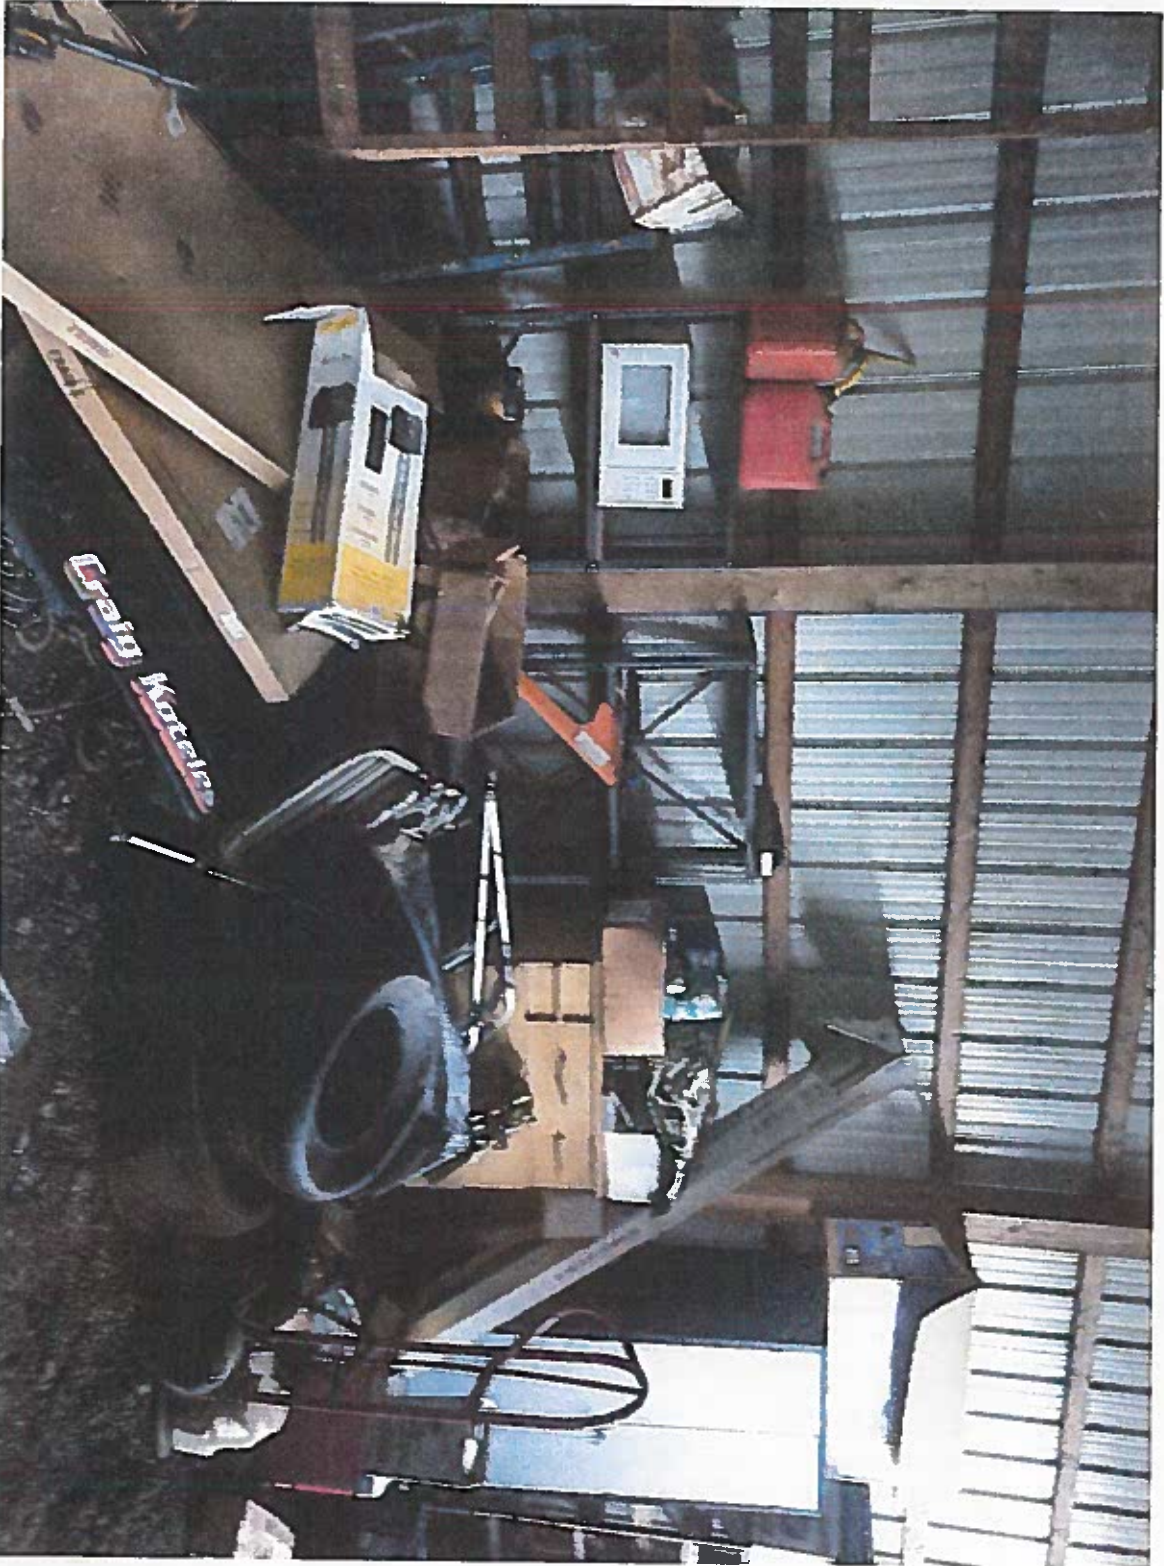
Debris pile in rear garage

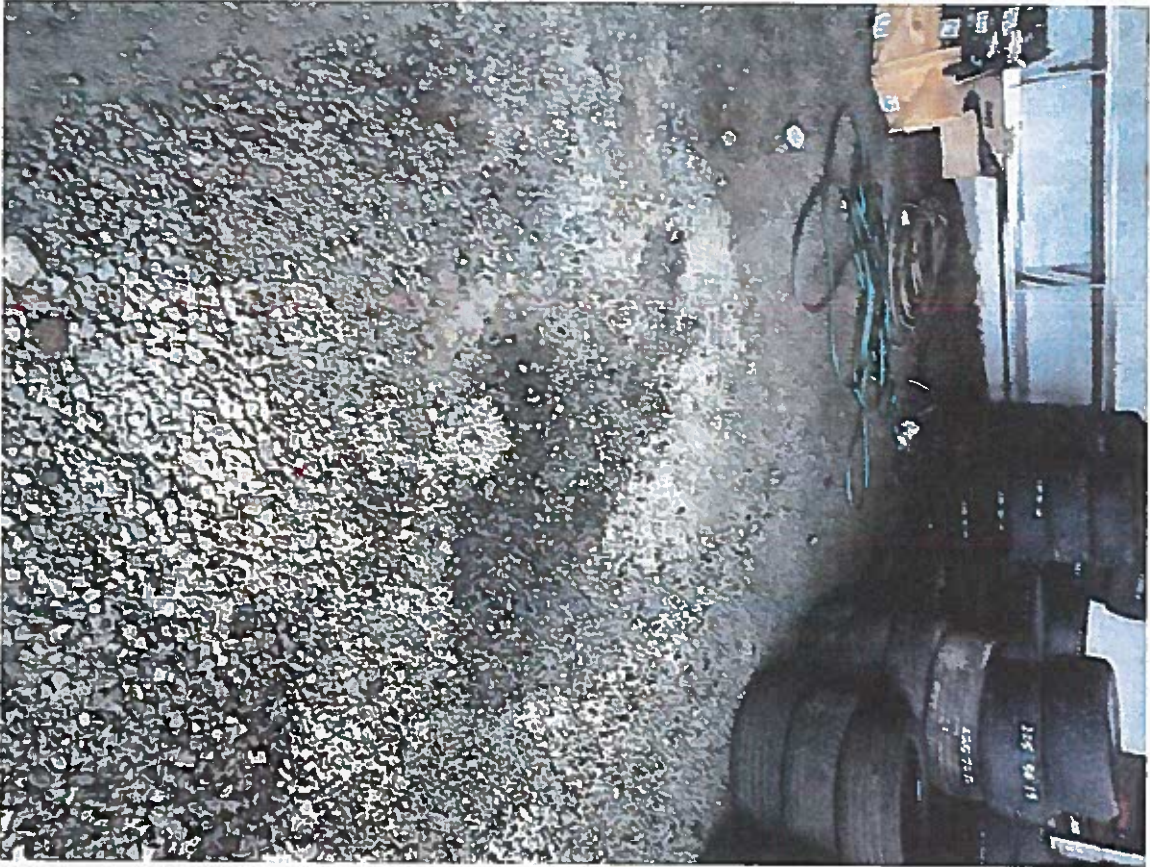
Oil spill on gravel in rear garage.

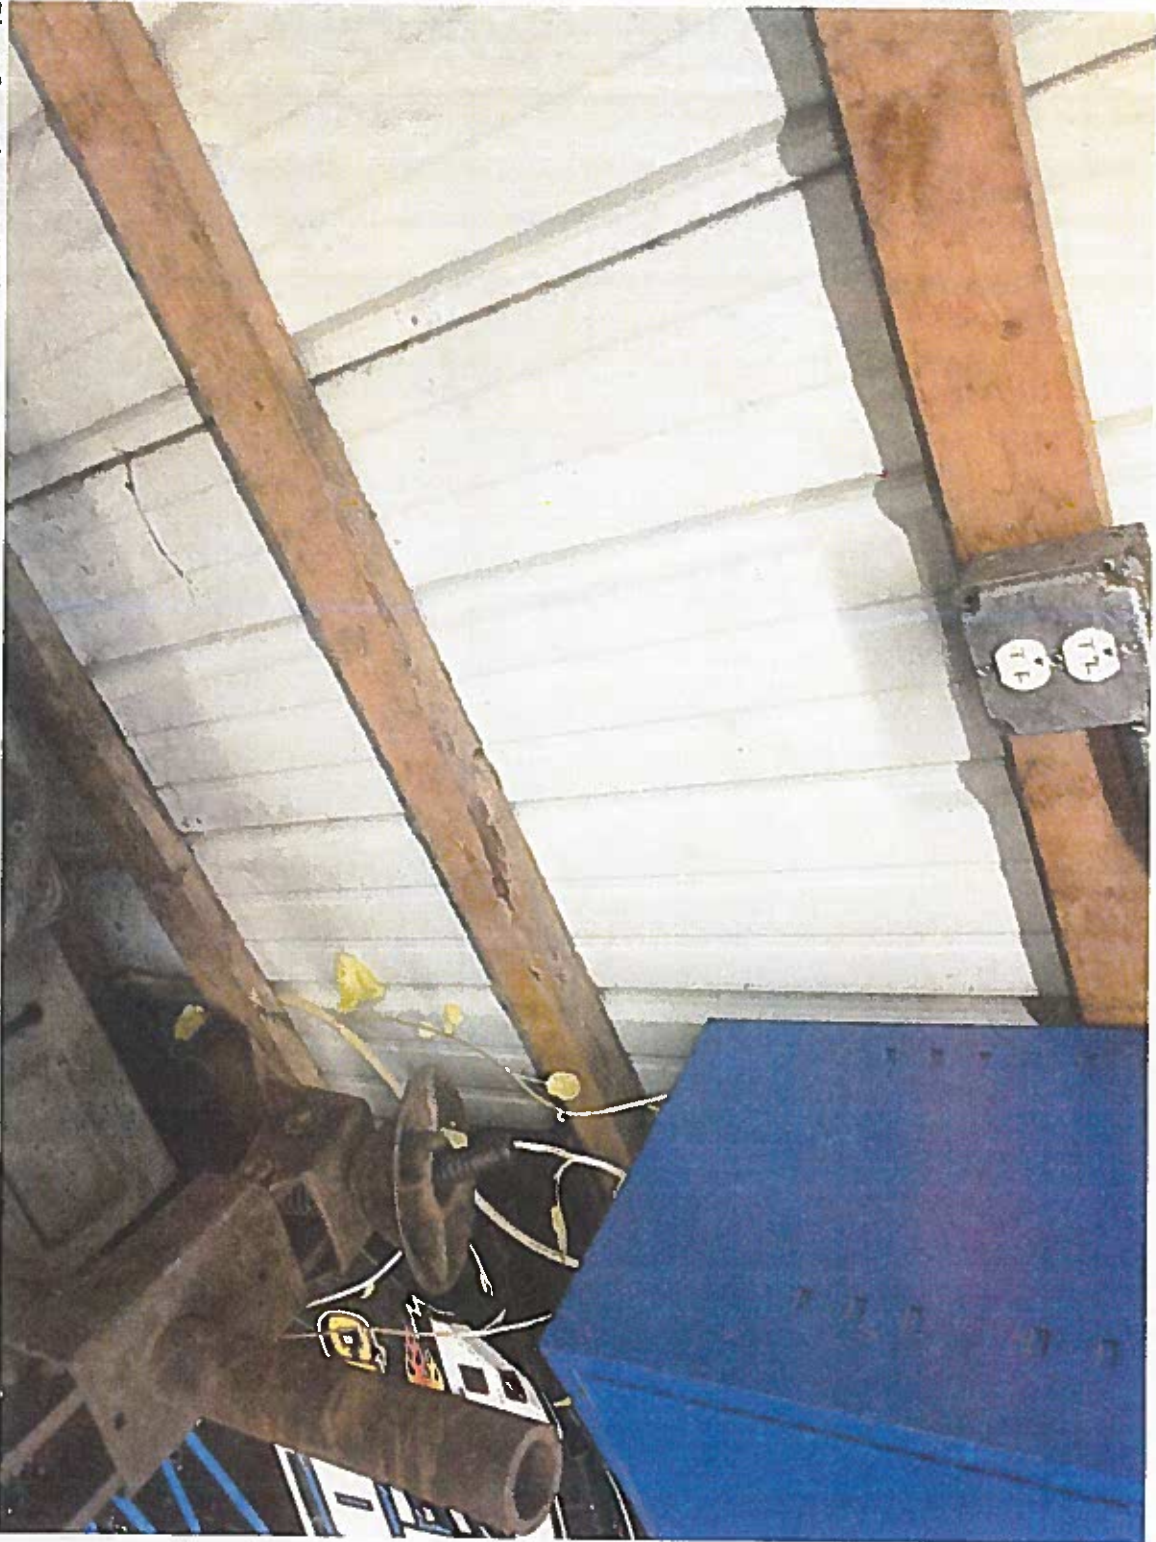
Plant from the outside is growing into the rear storage building.

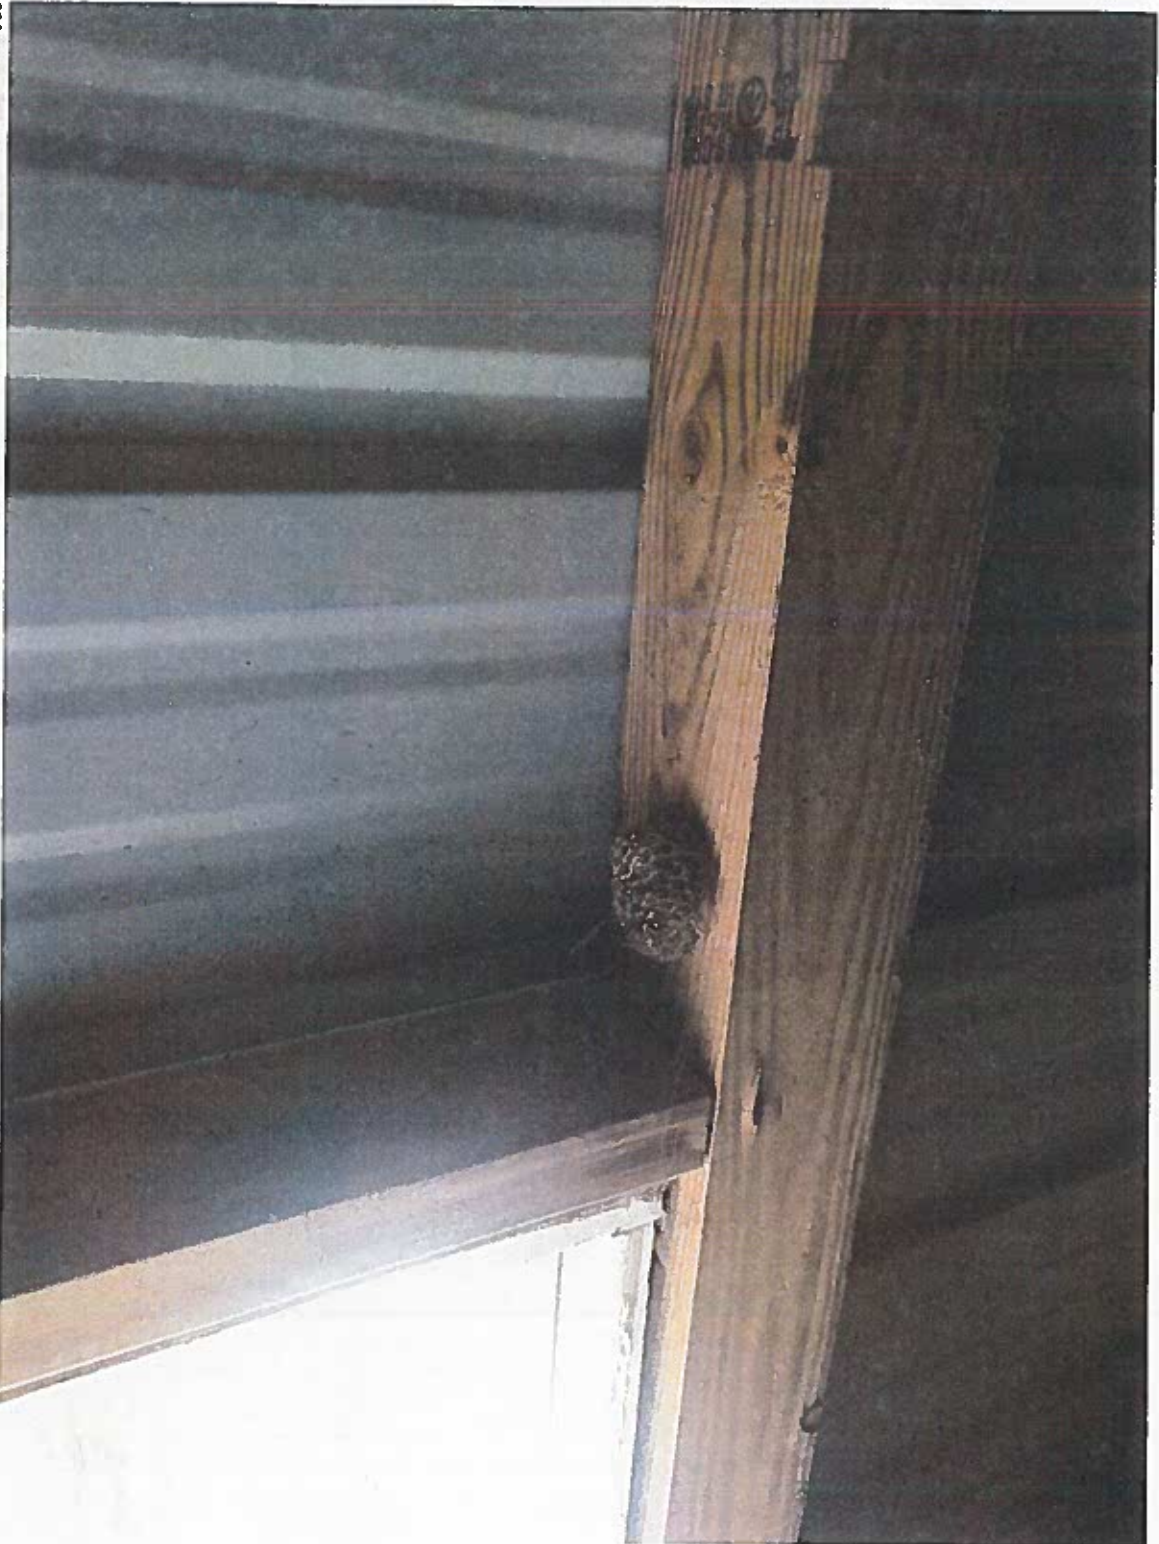
A wasp nest was found adjacent to the inside of the door to access the rear storage area.

Wasp nest near rear entry door.
